# EMERGENCY EVACUATION OF COMMERCIAL PASSENGER AEROPLANES

# Emergency Evacuation of Commercial Passenger Aeroplanes

A Specialist Paper prepared by the Flight Operations  
Group of the Royal Aeronautical Society

27 April 2018

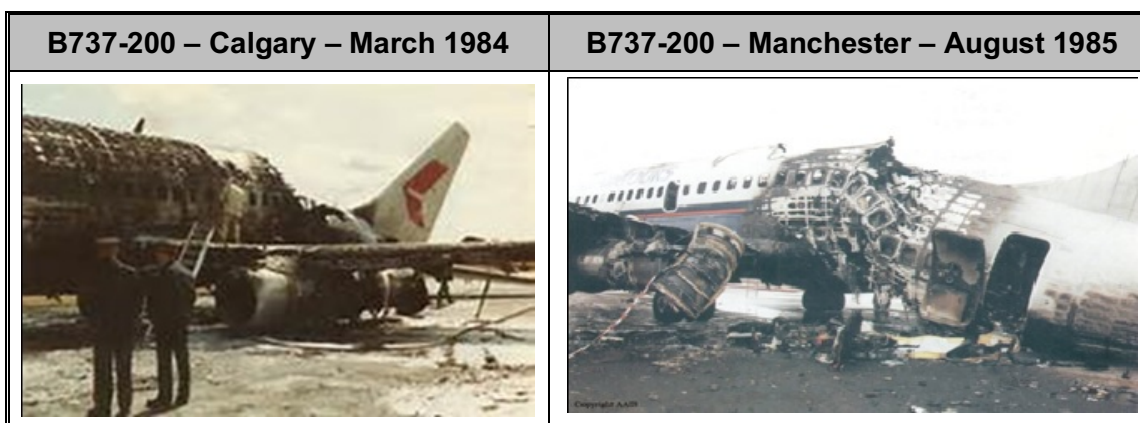
The aft left floor level Type I emergency exit (L3) was not opened during the evacuation due to the external fire. The aft right floor level Type I exit (R3) was opened by a cabin crew member some six seconds after the aeroplane came to a full stop and the evacuation slide was deployed and inflated. However, due to the intensity of the external fire this exit was unusable.

Fuselage burn-through of the Boeing 737 at Calgary and the Boeing 737 at Manchester are remarkably similar as shown in the photographs below, although burn-through on the Calgary accident aeroplane fuselage extends forward of the left wing whilst in the Manchester accident aeroplane, burn-through of the fuselage is only present seven windows aft of the left overwing Type III emergency exit (L2) and extending aft to the area of the rear left floor level Type I exit (L3).

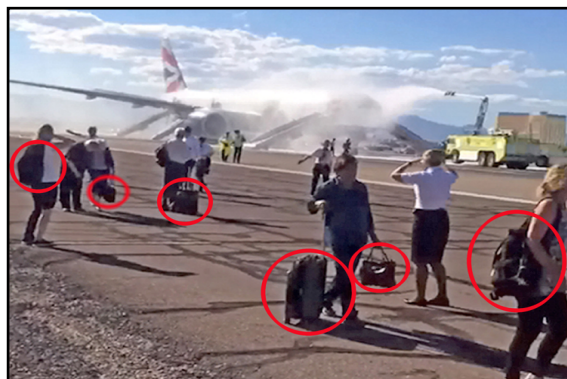
In the 2015 Las Vegas Boeing 777 accident many passengers evacuated the aeroplane with items of cabin baggage including suitcases. The FOG is of the opinion that a significant issue in this emergency evacuation was the number of passengers who took cabin baggage with them to the emergency exits and down the evacuation slides. Although this did not appear to affect the emergency evacuation, had the B777-200 been configured at its maximum capacity of 440 seats installed and passengers carried, the evacuation time might have been dangerously extended.

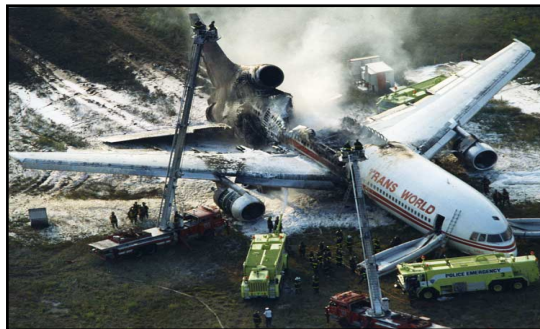
### 11.3 30 July 1992 - Trans World Airlines - Lockheed L1011 TriStar - New York, USA

On 30 July 1992, a Lockheed L1011 TriStar, operated by Trans World Airlines (TWA), (Flight Number 843), aborted take-off immediately after lift-off from John F Kennedy International Airport at New York, USA. On board were 280 passengers, three flight crew and nine flight attendants. According to the NTSB Accident Report the aeroplane was airborne for approximately six seconds and came to rest upright and on fire about 100 metres to the left of the departure end of the runway. The aeroplane was immediately engulfed with fire and was totally destroyed.

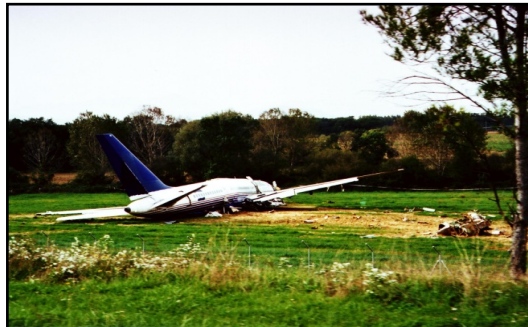
#### 11.4 14 September 1999 - Britannia Airways - Boeing 757-200 - Girona, Spain

On 14 September 1999, a Boeing 757-200, operated by Britannia Airways, (Flight Number 226A), was on its second attempt to land in adverse weather conditions at Girona, Spain, when it suffered a main landing gear failure on touch-down. On board were 236 passengers, two flight crew and seven cabin crew. The aeroplane left the runway and travelled some 350 metres before hitting a mound, becoming semi-airborne and then hitting a number of small trees and a boundary fence. The Boeing 757 came to rest in a field off the airport.

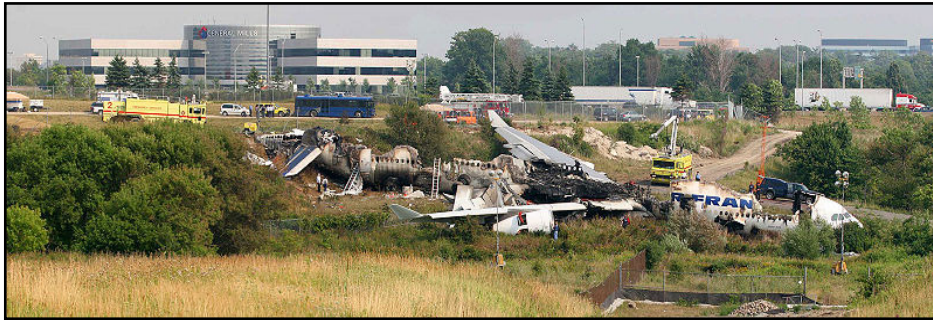
**2 August 2005 - Air France - Airbus A340-300 - Toronto, Canada**

On 2 August 2005, an Airbus A340-300, operated by Air France, (Flight Number 358) touched down on runway 24L at Toronto, Canada, but according to the TSB Accident Report further along the runway than usual, and was unable to stop. It departed the end of the runway and came to rest in a shallow gully with its fuselage split into several pieces. Approximately four minutes later, the A340 fuselage erupted in flames. On board were 297 passengers and 12 crew.

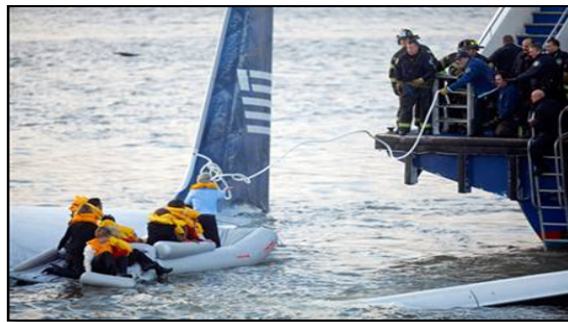
#### **11.7                      15 January 2009 - US Airways - Airbus A320-200 - Hudson River, New York, USA**

On 15 January 2009, an Airbus A320-200, operated by US Airways, (Flight Number 1549), departing La Guardia Airport at New York, struck a flock of Canada Geese on initial climbout. According to the NTSB Accident Report, the aeroplane suffered an immediate and almost complete loss of thrust in both engines. On board were 150 passengers, two flight crew and three flight attendants. Air temperature at the time of the accident was approximately 19°F (-7.22°C) with a wind chill factor of 2°F (-16.7°C).

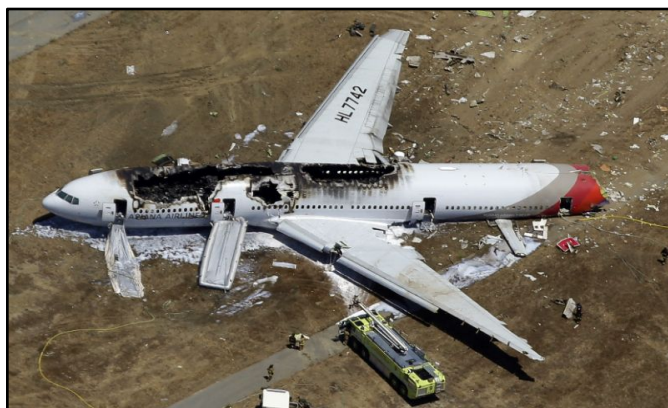
#### 11.9 6 July 2013 - Asiana Airlines - Boeing 777-200 - San Francisco, USA

On 6 July 2013, a Boeing 777-200 operated by Asiana Airlines, (Flight Number 214), crashed on final approach to San Francisco, USA, with a descent below the glidepath resulting in an impact with a seawall. On board were 291 passengers, four flight crew and 12 flight attendants.

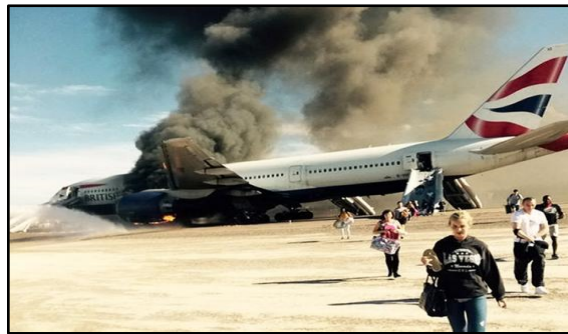
### 11.10 8 September 2015 - British Airways – Boeing 777-200 - Las Vegas, USA

On 8 September 2015, a Boeing 777-200 operated by British Airways, (Flight Number 2276), suffered an uncontained failure of the number 1 engine on take-off from Las Vegas, USA. On board were 157 passengers, three flight crew and ten cabin crew.

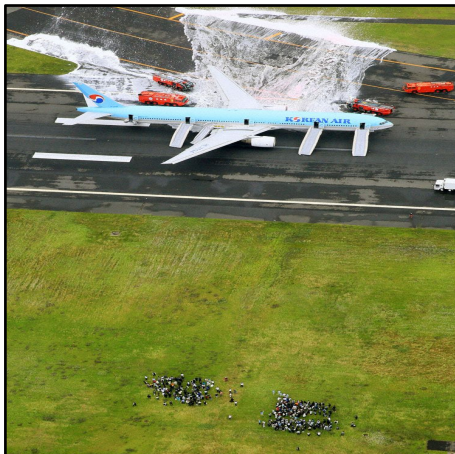
#### 11.11 27 May 2016 - Korean Air - Boeing 777-300 - Tokyo, Japan

On 27 May 2016, a Boeing 777-300 operated by Korean Air, (Flight Number 2708), suffered an uncontained failure of the number 1 engine on take-off from Tokyo, Japan. On board were 302 passengers and 17 crew. In the emergency evacuation five emergency exits on the right side of the aeroplane were operated as well as exit L1. The evacuation slide at Door R5 inflated but deployed underneath the aeroplane fuselage and was not useable during the evacuation. It has been reported that there were no fatalities and some 12 non-fatal injuries.

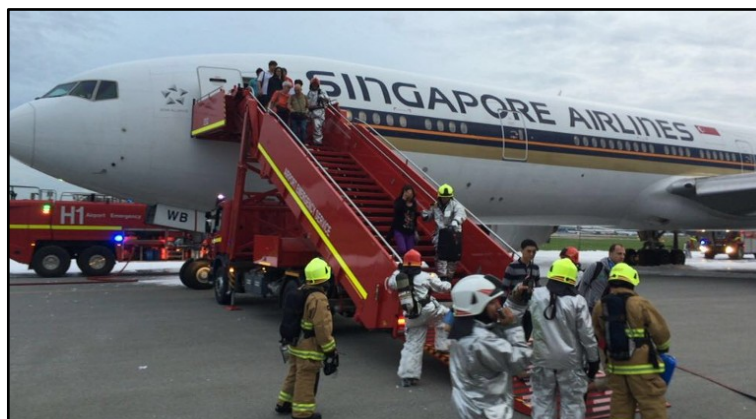
### 11.13 27 June 2016 - Singapore Airlines - Boeing 777-300 - Singapore

On 27 June 2016, a Boeing 777-300 operated by Singapore Airlines, (Flight Number 368), returned to Singapore after the number 2 engine warning light showed a low oil quantity. According to the Singapore Transport Investigation Bureau Accident Report, on landing at Singapore the number 2 engine caught fire and the right wing became engulfed in flames. On board were 222 passengers, four flight crew and 15 cabin crew.

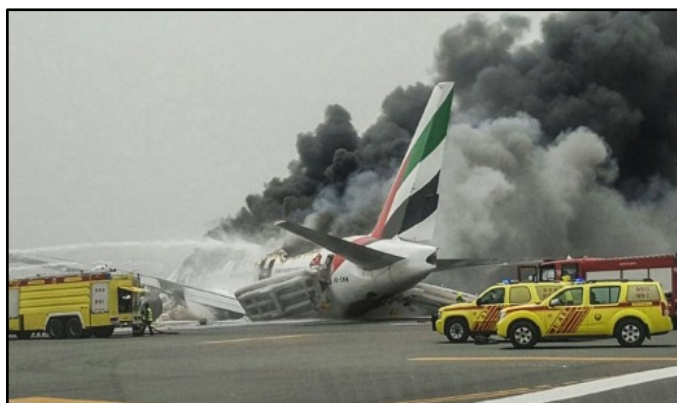
#### 11.14 3 August 2016 – Emirates - Boeing 777-300 - Dubai, UAE

On 3 August 2016, a Boeing 777-300 operated by Emirates, (Flight Number 521), crash landed on the runway at Dubai, UAE, after an attempted 'go-around'. On board were 282 passengers, two flight crew and 16 cabin crew. As the aeroplane slid along the runway, the Number 2 engine separated from the wing and an intense fuel fire was observed in this area, as well as fire to the underside of Number 1 engine.

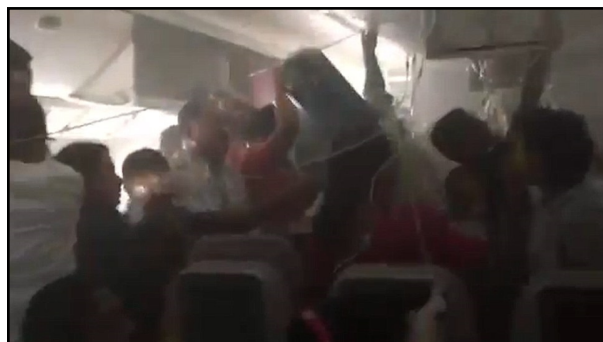
This was another accident in which passengers evacuated with cabin baggage. Images taken by passengers on mobile phones show overhead bins being open to retrieve baggage even though the evacuation had already commenced and a degree of urgency was obvious due to smoke in the cabin and the external fire. The Emirates General Civil Aviation Authority Preliminary Accident Report, stated: *"The cabin crew members followed the Operator's safety instructions that prohibit passengers taking their carry-on baggage during an evacuation, and they instructed the passengers to leave their bags behind. However, several passengers evacuated the Aircraft carrying their baggage."*
