EMERGENCY EVACUATION OF COMMERCIAL PASSENGER AEROPLANES

Emergency Evacuation of Commercial Passenger Aeroplanes

A Specialist Paper prepared by the Flight Operations
Group of the Royal Aeronautical Society

27 April 2018

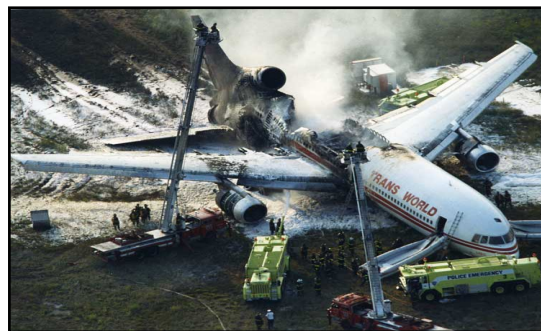
11.3 30 July 1992 - Trans World Airlines - Lockheed L1011 TriStar - New York, USA

On 30 July 1992, a Lockheed L1011 TriStar, operated by Trans World Airlines (TWA), (Flight Number 843), aborted take-off immediately after lift-off from John F Kennedy International Airport at New York, USA. On board were 280 passengers, three flight crew and nine flight attendants. According to the NTSB Accident Report the aeroplane was airborne for approximately six seconds and came to rest upright and on fire about 100 metres to the left of the departure end of the runway. The aeroplane was immediately engulfed with fire and was totally destroyed.

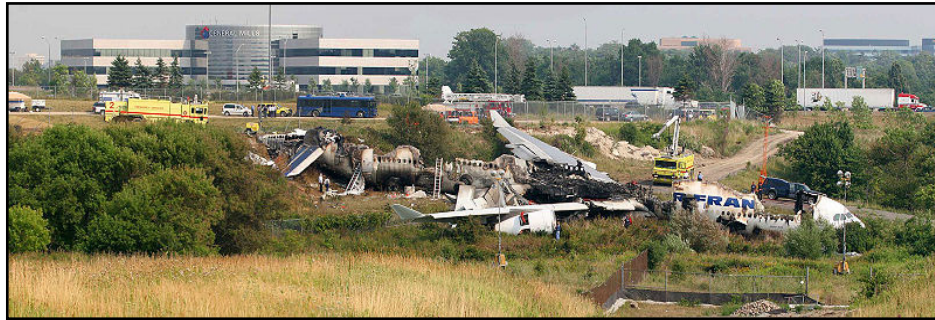
2 August 2005 - Air France - Airbus A340-300 - Toronto, Canada

On 2 August 2005, an Airbus A340-300, operated by Air France, (Flight Number 358) touched down on runway 24L at Toronto, Canada, but according to the TSB Accident Report further along the runway than usual, and was unable to stop. It departed the end of the runway and came to rest in a shallow gully with its fuselage split into several pieces. Approximately four minutes later, the A340 fuselage erupted in flames. On board were 297 passengers and 12 crew.

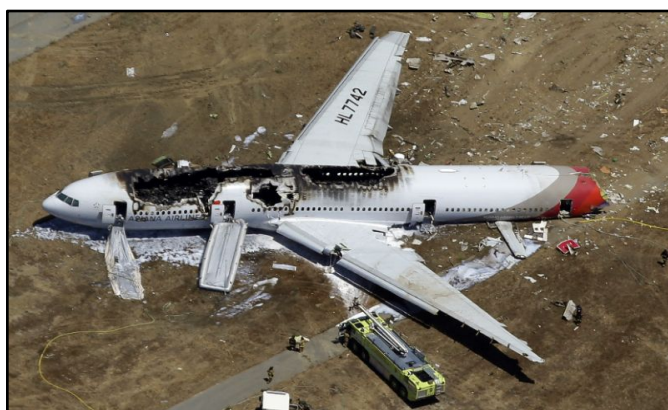
11.9 6 July 2013 - Asiana Airlines - Boeing 777-200 - San Francisco, USA

On 6 July 2013, a Boeing 777-200 operated by Asiana Airlines, (Flight Number 214), crashed on final approach to San Francisco, USA, with a descent below the glidepath resulting in an impact with a seawall. On board were 291 passengers, four flight crew and 12 flight attendants.

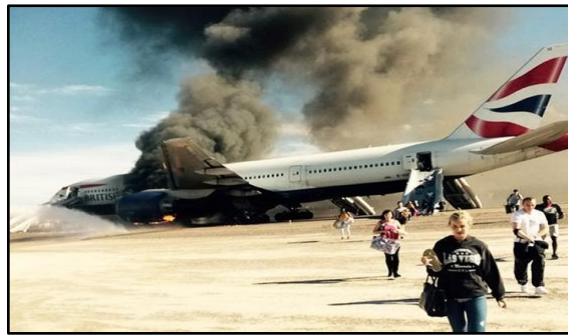
11.10 8 September 2015 - British Airways – Boeing 777-200 - Las Vegas, USA

On 8 September 2015, a Boeing 777-200 operated by British Airways, (Flight Number 2276), suffered an uncontained failure of the number 1 engine on take-off from Las Vegas, USA. On board were 157 passengers, three flight crew and ten cabin crew.

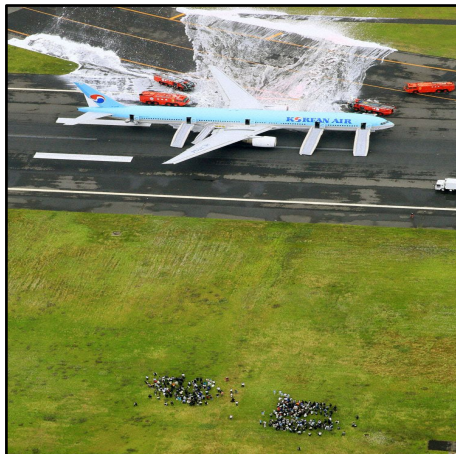
11.11 27 May 2016 - Korean Air - Boeing 777-300 - Tokyo, Japan

On 27 May 2016, a Boeing 777-300 operated by Korean Air, (Flight Number 2708), suffered an uncontained failure of the number 1 engine on take-off from Tokyo, Japan. On board were 302 passengers and 17 crew. In the emergency evacuation five emergency exits on the right side of the aeroplane were operated as well as exit L1. The evacuation slide at Door R5 inflated but deployed underneath the aeroplane fuselage and was not useable during the evacuation. It has been reported that there were no fatalities and some 12 non-fatal injuries.

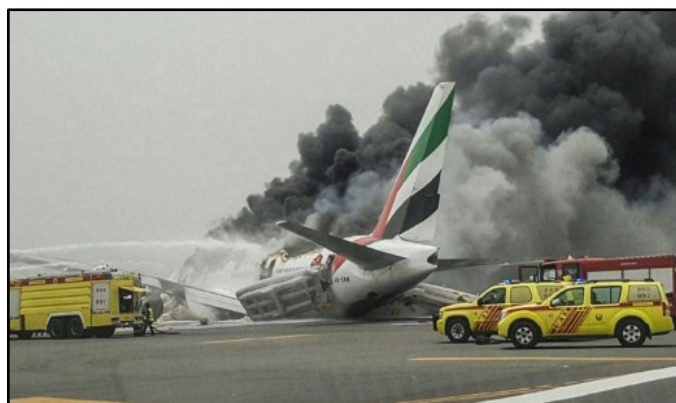
11.14 3 August 2016 – Emirates - Boeing 777-300 - Dubai, UAE

On 3 August 2016, a Boeing 777-300 operated by Emirates, (Flight Number 521), crash landed on the runway at Dubai, UAE, after an attempted 'go-around'. On board were 282 passengers, two flight crew and 16 cabin crew. As the aeroplane slid along the runway, the Number 2 engine separated from the wing and an intense fuel fire was observed in this area, as well as fire to the underside of Number 1 engine.
