SMOKE, FIRE AND FUMES IN TRANSPORT AIRCRAFT

PAST HISTORY, CURRENT RISKS AND RECOMMENDED MITIGATIONS

Part 2: Training

A Specialist Paper by the **Royal Aeronautical Society**

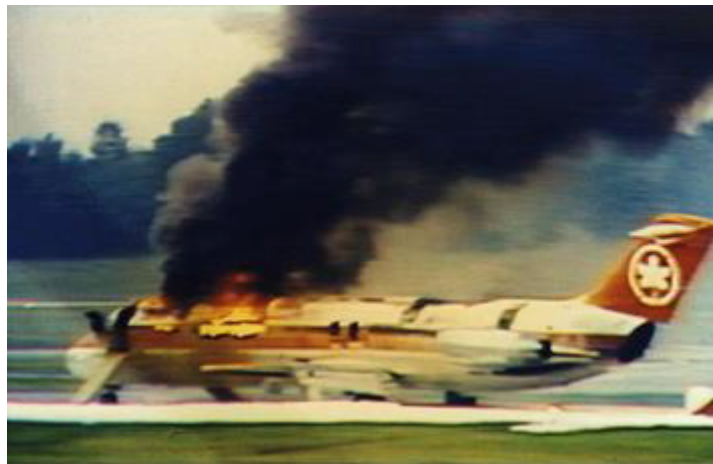
DC-9 accident – Cincinnati June 1983

In Advisory Circular (AC) 120-80A – In-flight Fires (FAA, 2014), the FAA identified that the time for the situation to become non-survivable was as little as seven minutes, and that only in one third of hidden fire events would the aircraft reach an aerodrome before the fire became uncontrollable. An example of this is the accident involving an Air Canada DC-9 which diverted to Cincinnati in June 1983 when a lavatory compartment fire became uncontrollable (NTSB, 1986).

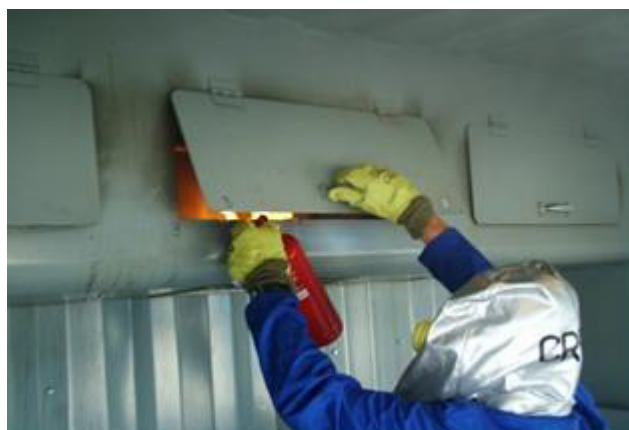
Combining fire extinguisher training with PBE training is certainly feasible since some operators and training organisations achieve both elements in one practical fire training scenario. Therefore, regulatory requirements should reflect the likelihood of an in-flight fire in which different items of fire safety equipment need to be used simultaneously. Attempting to meet practical fire training requirements in unrealistic, separate fire training scenarios is not satisfactory.

Combining fire extinguisher training with PBE training & fire gloves
