## **SMOKE, FIRE AND FUMES IN TRANSPORT AIRCRAFT**

PAST HISTORY, CURRENT RISKS AND RECOMMENDED MITIGATIONS

Part 1: Reference

Fifth Edition 2018

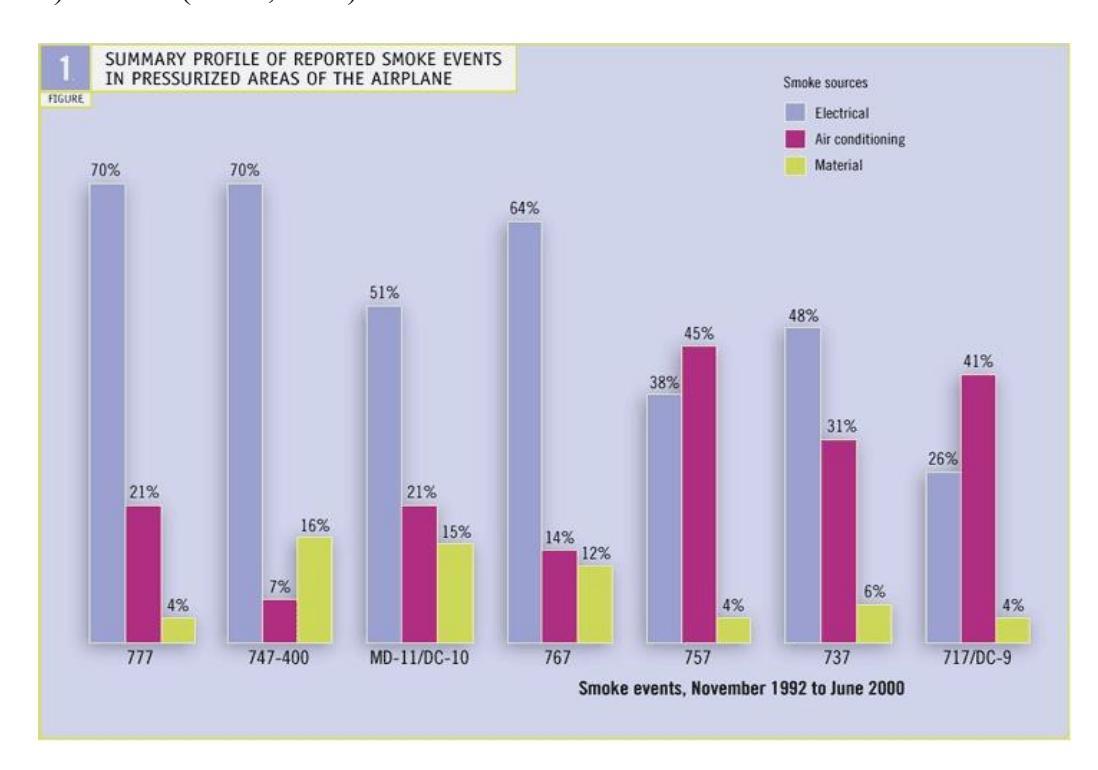
fires is aeroplane wiring. In modern large transport aeroplanes there are over 500,000ft (150km) of wire. (Potter, 2003)

As the complexity and diversity of systems have grown in transport jets, so has the amount of wire. The addition of more wire has increased the probability of wiring related problems and fires, leading the industry to recognising that the wiring does not last the life of the aeroplane (Teal, 2001). The increasing complexity of electrical installations, especially on larger aeroplanes with premium class cabins, will result in further issues. Such installations include, but are not limited to, IFE Systems, electrically operated seats and charging systems for computers or other electronic devices. Each system installed in an operator's aeroplane can require unique procedures to deal with a failure or a problem that might result in an in-flight fire. Another issue is the addition of new systems to aeroplanes using existing circuit breakers to power the new equipment. The FAA Technical Center found this to be the case in a study of 316 circuit breakers. They found that:

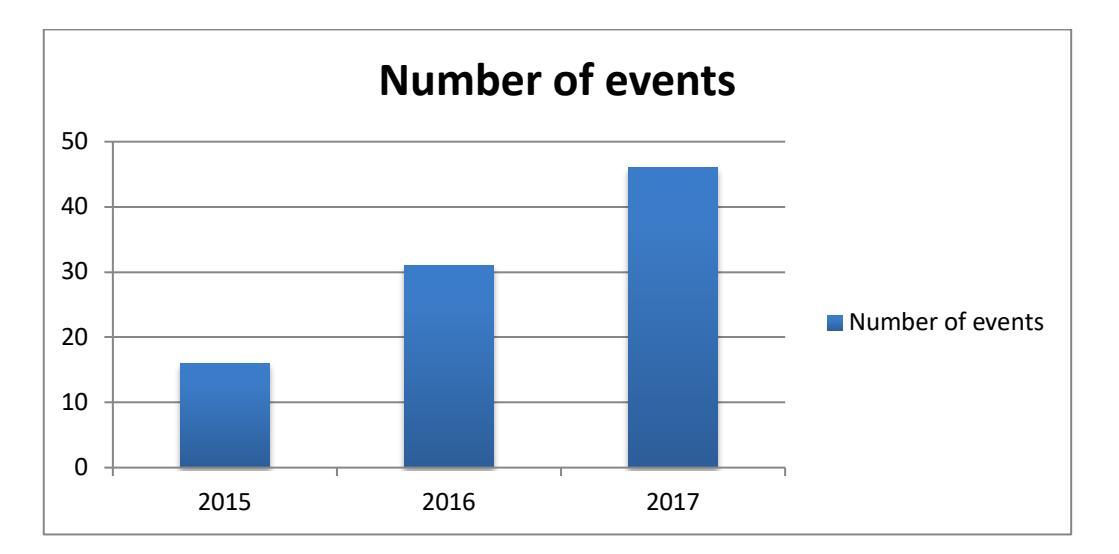
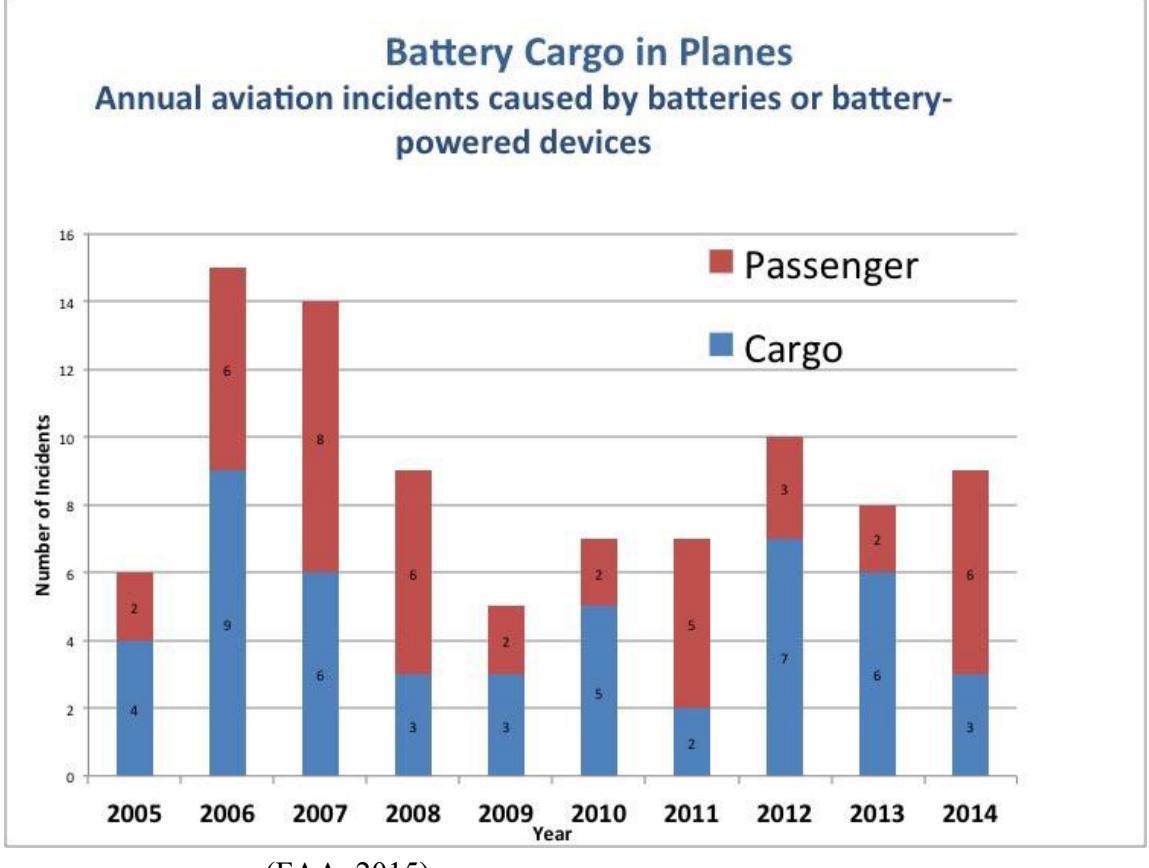
(FAA, 2015)

One of the largest trends in the growth of in-flight fires is due to the transportation of lithium batteries. From March 1991 to August 2018, the FAA office of Security and Hazardous Materials Safety recorded 225 cases of aviation incidents involving smoke, fire, extreme heat or explosion involving batteries and battery powered devices (FAA, 2018). Lithium batteries were the majority of battery types in the incidents. Of particular concern is the increasing number of lithium battery fires

onboard aeroplanes. In 2018 between January and August there were 34 events, in 2017 there were 46 events, in 2016 there were 31, and in 2015 there were 16 (FAA 2018).

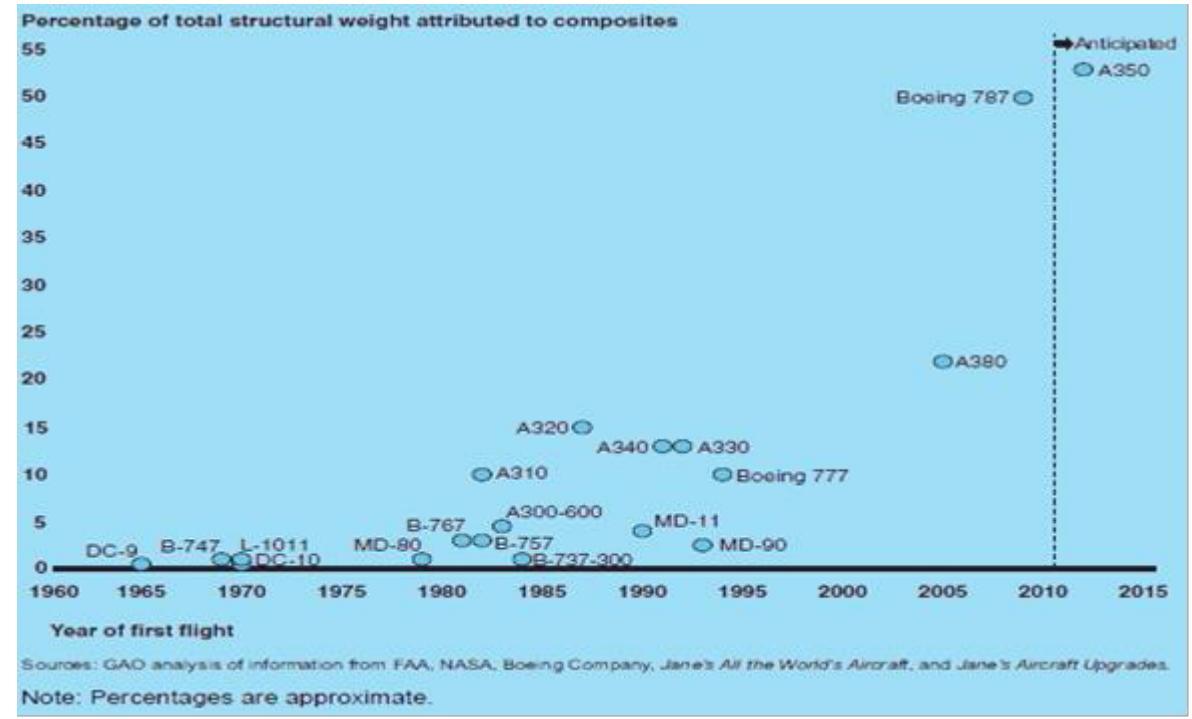
The following figure shows the percentage of total structural weight attributed to composite materials used in aeroplane construction since the mid-1980s:

(United States Government General Accountablity Office, 2011)
